# ***NEWNES KAOLIN PTY LTD***

**Sand quarry & kaolin mine**

**Annual Environmental Management Report for year ending December 2019**

**Re: Newnes Kaolin Sandmine – DA 329-7-2003  
Newnes Junction – Sandham Road  
Fifth Annual Environmental Management Report  
Period - 1<sup>st</sup> January 2019 to 31<sup>st</sup> December 2019**

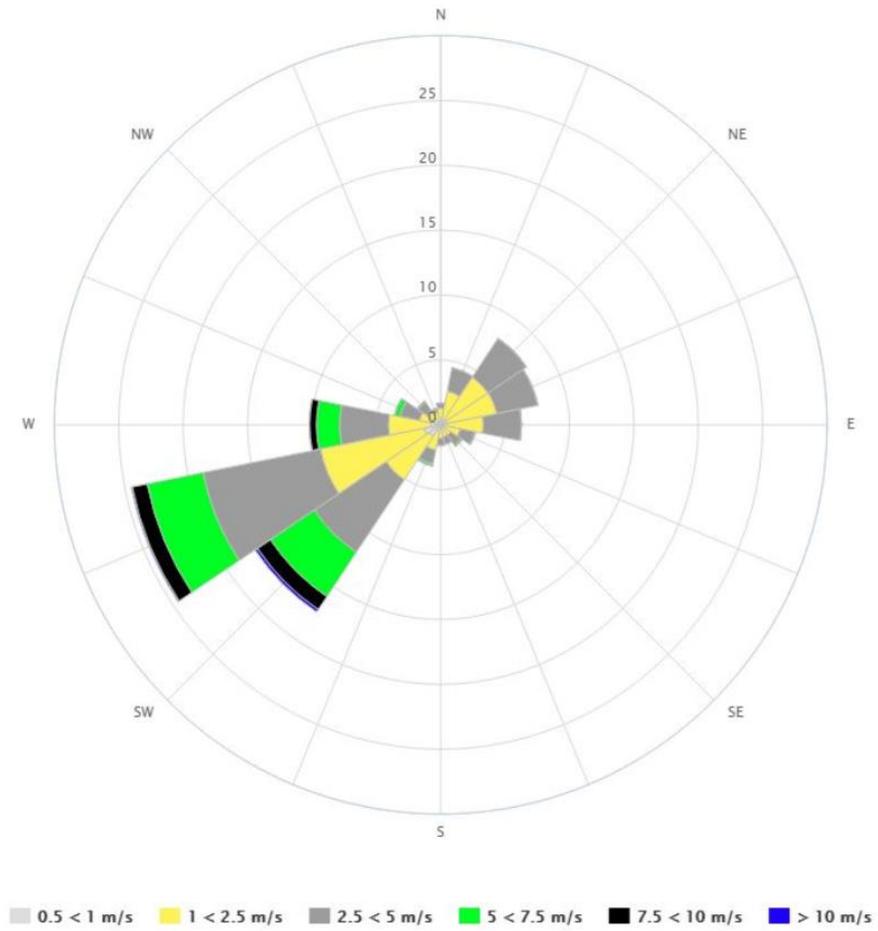
Clarence wind rose – January 2019 to December 2019 – submitted as additional weather data to compliment data from the Newnes kaolin Met Stn for 2019

Newnes Kaolin P/L are fortunate to have access to the annual wind rose for the neighbouring Clarence Colliery weather station during 2019. A comparison of the Newnes kaolin weather station wind rose and the Clarence colliery wind rose indicates that both stations are recording similar measurements with winds flowing along a west – southwest to east – northeast axis for the area.

As stated above the data from the Newnes kaolin weather station and the Clarence Colliery weather station correlate. Refer to Appendix 3.

**Todoroski Air Sciences** have compared the wind data available from the repaired Newnes kaolin weather station with the annual wind rose from the nearby Clarence Colliery weather station. Comparison of the weather station suggests a similar pattern of wind and implies the newly repaired weather station is recording sensible wind speeds and directions.
